**CHAPTER 5**  
**ENGINEERING**  
**(R645-301-500)**

## **ENGINEERING (R645-301-500)**

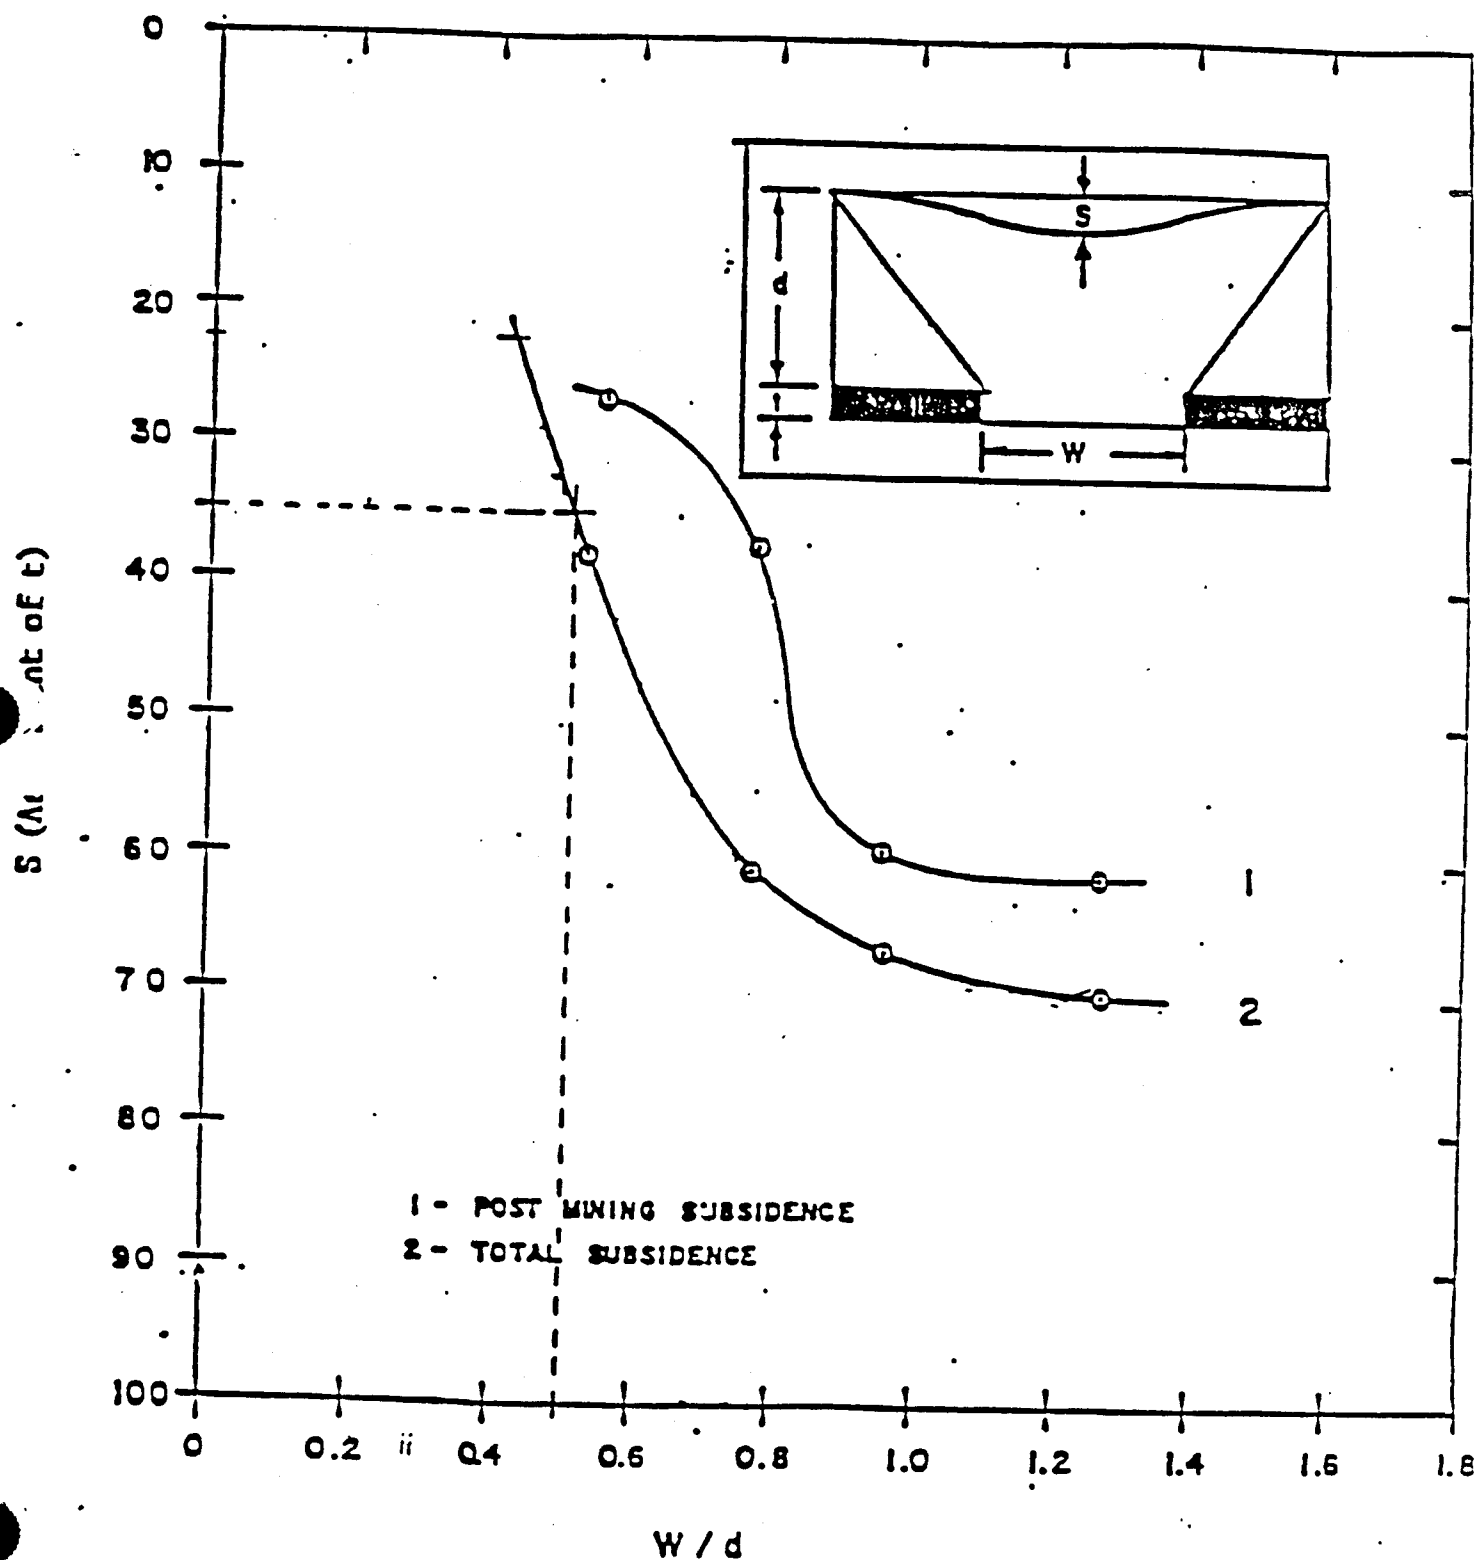
FIGURE 5-4

# MAXIMUM SUBSIDENCE GRAPH

Maximum subsidence, as a percentage of seam thickness, versus width/depth ratio for room and pillar mining at Somerset, Colorado (after Dunrud, 1980).

The magnitude of vertical subsidence is a function of coal height, overburden depth, stratigraphy, mining technique, and distance from barrier pillars. According to Dunrud's work completed in 1980, based upon a study of subsidence in an underground coal mine at Somerset, Colorado, published by the USGS in 1980, the maximum amount of subsidence expected is equal to 70% of the coal seam extracted, refer to Figure 5-4. The Somerset subsidence curves are included as reference within this report as the overburden characteristics are similar to that encountered at Crandall Canyon and the lack of reported data indicating amounts of subsidence for western underground coal mines. The maximum subsidence experienced for western coal mines according to Peng, ranges from 33 to 65% of the coal height extracted. Gentry and Abel have cited examples with maximum subsidence ranging to 70% of the seam height for western U. S. longwall operations. A 70% value will be used within this report. The maximum value may be reduced by the amount of coal not recovered in the mining areas, i.e., 20% of the coal is expected to be unrecoverable in the pillared areas at the Crandall Canyon Mine. For the areas near an unmined solid pillar the maximum amount of subsidence is reduced according to the graph shown in Figure 5-5 based upon referenced work in the United Kingdom by Gentry and Abel. The largest magnitude of subsidence that may occur is 3.9 feet at a point 40 feet east of the section line between Sections 5 and 6 and 1522 feet south of the section line between Sections 32 and 5. The values were calculated by reducing the coal heights shown on Plated 5-2C by 20% which represents the unrecoverable coal in the pillared areas (a six foot coal height was assumed due to lack of data), then multiplying by 70% to obtain the maximum possible subsidence value as obtained from Figure 5-4 which assumes a worse case scenario. The subsidence values were reduced according to Figure 5-5 for areas that border a barrier pillar along the perimeter of the lease shown on Plate 5-2.

The method used in calculating subsidence magnitude as discussed within this section and Figures 5-4 and 5-5, the maximum amount of possible subsidence is only 3.5 feet, and occurs in the central portions of lease ML-21568. This 3.5 feet subsidence is worst case and will probably be in the order of 3 to 4 inches according to TerraTek.

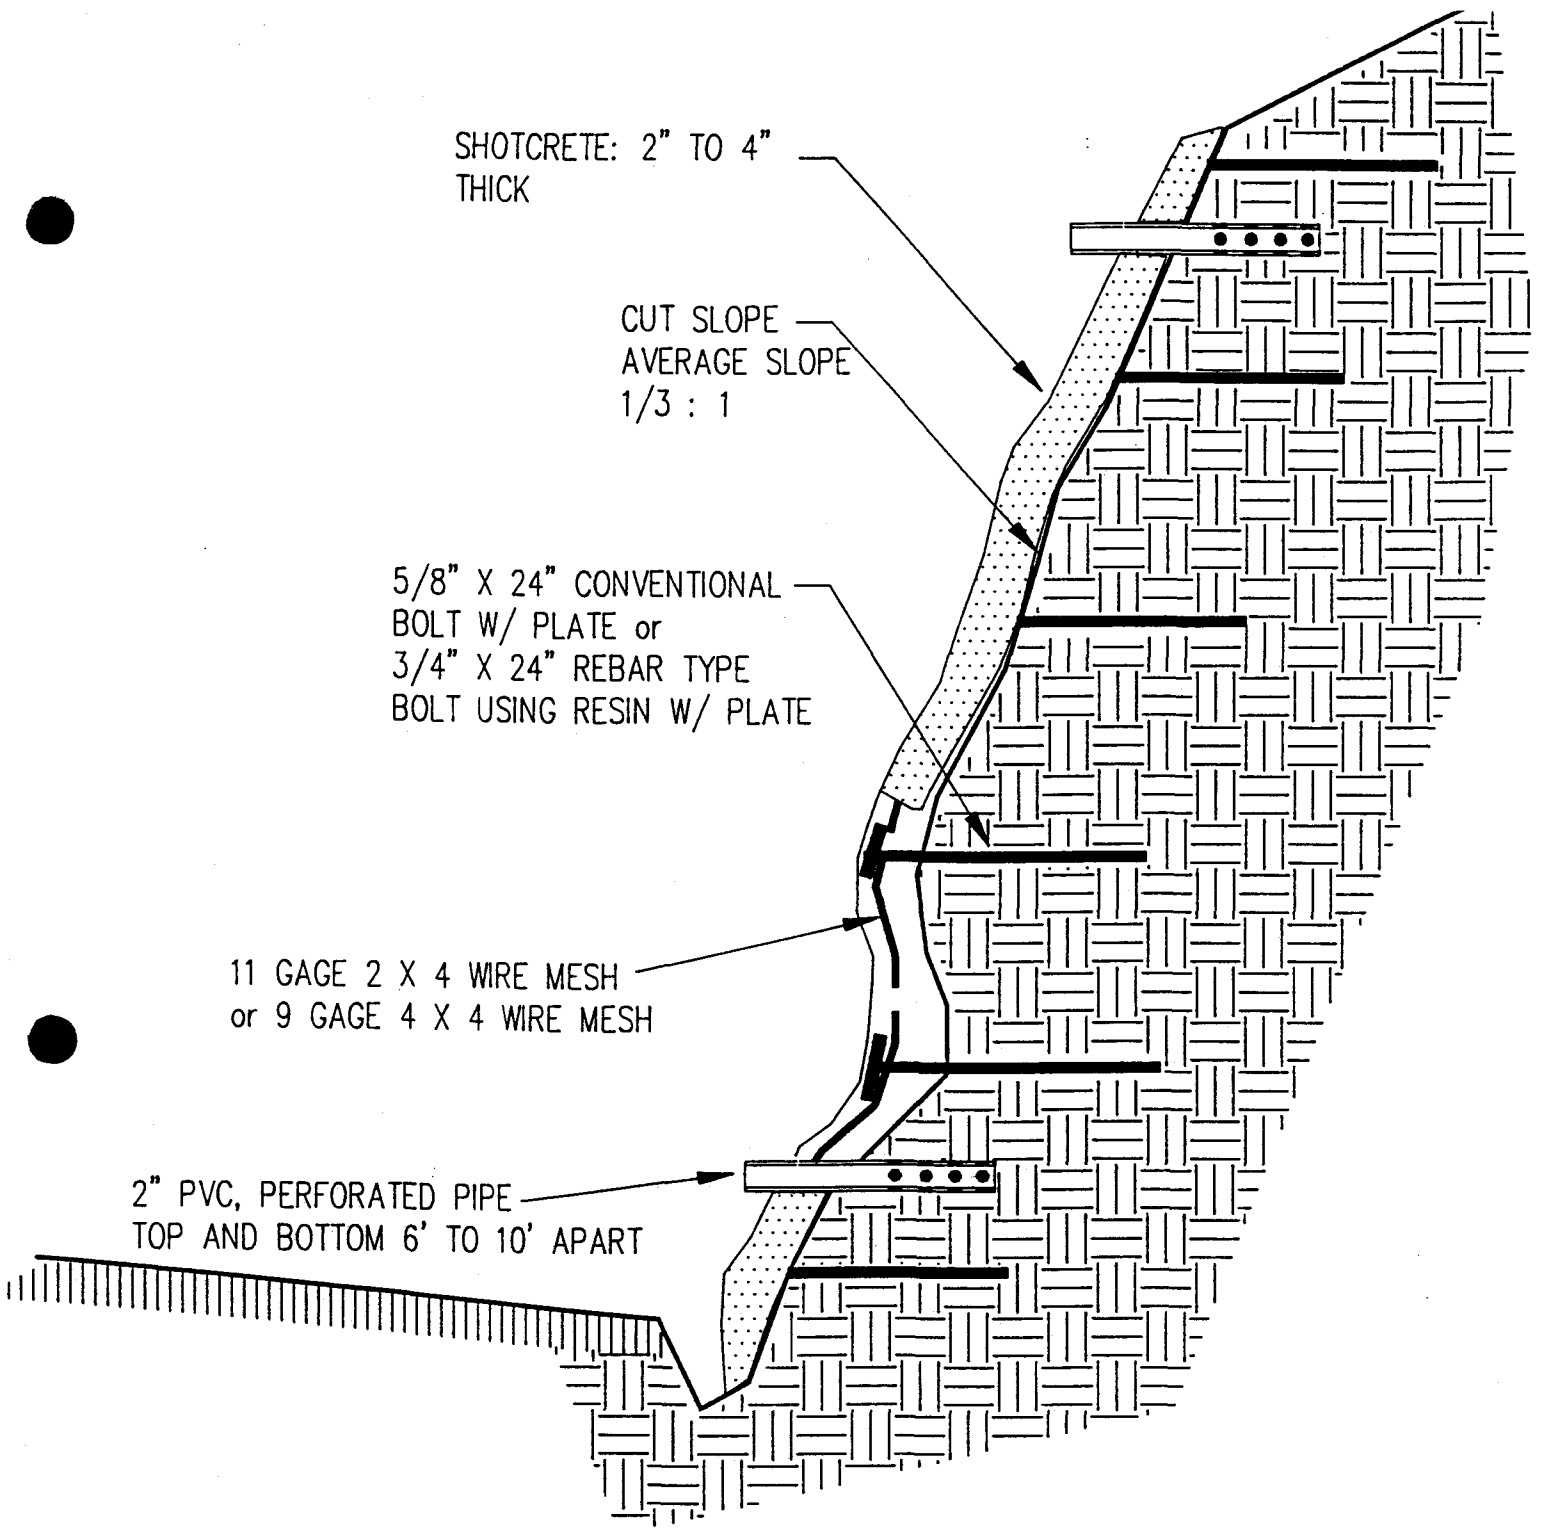
Average slope: 1/3:1  
Matting: 11 gage 2" x 4" or 9 gage 4" x 4" wire mesh  
6' wide x full length of slope  
Securement: 5/8" x 24" long bolts w/ plates or  
3/4" x 24" long rebar type anchors w/ plates  
spacing maximum 5' centers  
Drainage: 2" PVC pipe, 24" long, perforated, located  
at top and bottom of slope, 6' to 10'  
on centers. Pipes will be inset into the slope  
with the end extending outside the shotcrete.  
Drainage of the slope will be collected by  
the 2" PVC pipes and allowed to flow to the  
outside of the shotcrete.  
Shotcrete: 1800 lbs sand  
(per batch) 800 lbs pea gravel  
425 lbs cement  
400 lbs fly ash  
Application: Applied with a Reed Sova III or  
Reed M40 pump w\ accelerator.  
Minimum thickness applied 2"

TYPICAL SHOTCRETE APPLICATION  
TO CUT SLOPES  
SCALE: NONE

See Figure 5-10 for a cross sectional detail of shotcrete application.
